**CHARACTERIZATION AND ANALYSIS OF THE CALICHE WALLS OF
THE GREAT HOUSE, CASA GRANDE RUINS NATIONAL
MONUMENT, COOLIDGE, ARIZONA**

A THESIS

Historic Preservation

1999

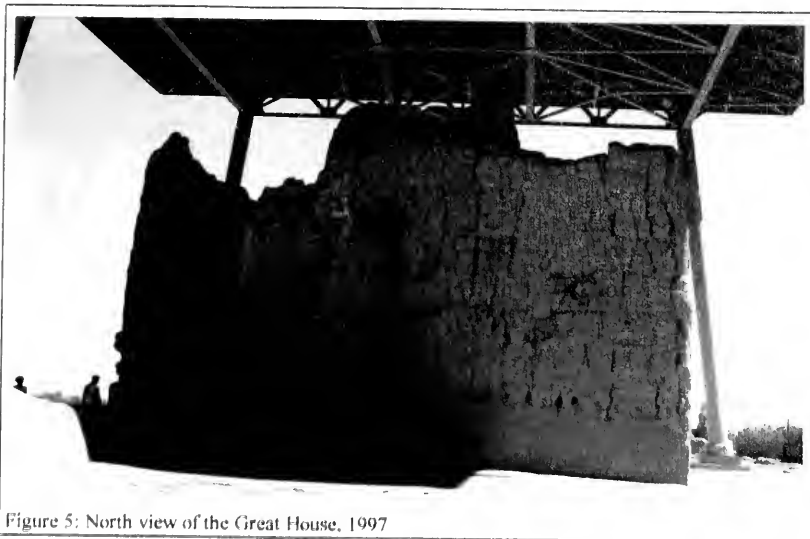
Figure 5: North view of the Great House, 1997

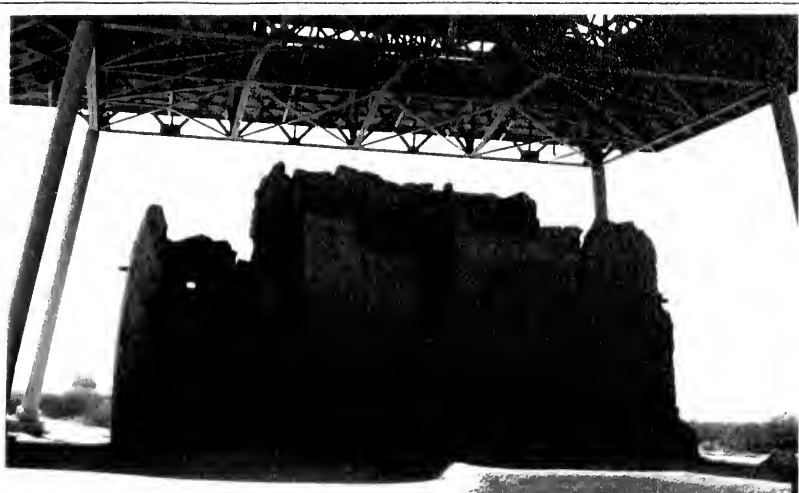
Figure 7: East View of the Great House, 1997

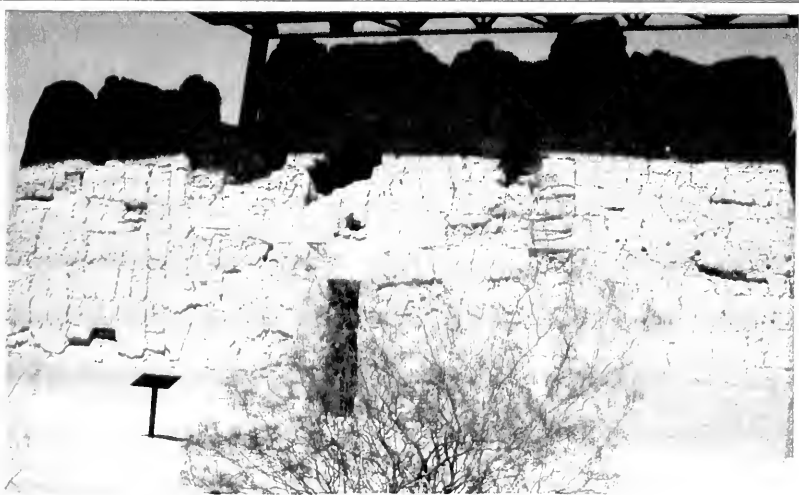
Figure 8: West View of the Great House, 1997

The walls of the Great House, which are approximately 1.35m (4' 5") thick for the exterior walls and 1.07m (3' 6") for the interior walls, were erected in semi-continuous horizontal courses of caliche of variable height. All interior walls and the interior side of the exterior walls were plastered, forming a planar and almost perpendicular surface, which was smoothed and painted with a thin clay-based finish.

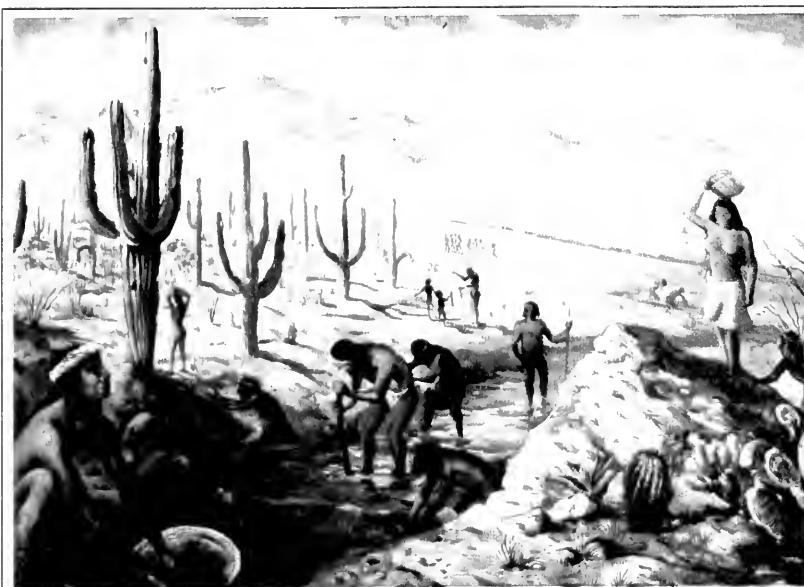
Figure 10: Painting (anonymous) that represents a channel dug by Hohokams. Notice the use of water to help soften and extract the caliche. This method was probably similar to the one used for extraction of caliche for construction purposes. Painting courtesy of Casa Grande Ruins National Monument.

Borrow area studies of other nearby Classic Hohokam sites, such as those by Burton, Knoob, Shrock, Spears and Phinney (1972) at Pueblo Grande in Phoenix, Arizona, provide valuable information on these issues. These data strongly suggest that the Hohokams preferred the purer caliche for its greater strength and hardness. In addition, certain characteristics of the Pueblo Grande borrow pits (ridges between pits, deep and sometimes undercut walls) seem to confirm that water was deliberately used to soften the caliche beds (Burton et al. 1972, 21-54).

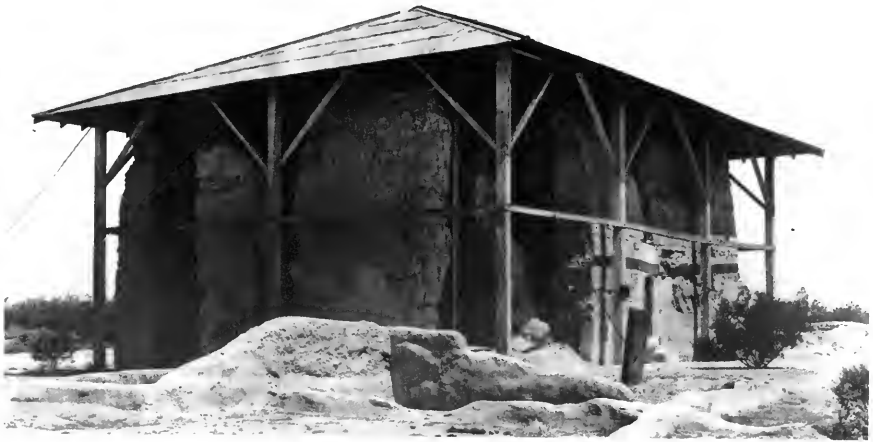
Figure 12: The original shelter roof, constructed in 1903 (Photo: courtesy of Casa Grande Ruins National Monument).

By the end of the nineteenth century, several requests were made for the addition of a shelter for the protection of the Great House. In 1890, Mindeleff's recommendations included a plan for such a shelter for the Great House. In 1893, 1895, and 1899, Custodian Isaac T. Whittemore repeatedly asked the Government for funds to be spent to protect the structure. Later, custodians H. B. Mayo and Frank Pinkley had concerns with the deterioration of the structure as well and also requested a roof for the protection of the Great House (Clemensen 1992, 40-50).

In 1915, James Bates, custodian of the monument, recommended a new roof for the Great House since the old galvanized roof had many holes and was leaking. By the mid-1920s it had become apparent that the roof of the Great House had deteriorated to the point that it

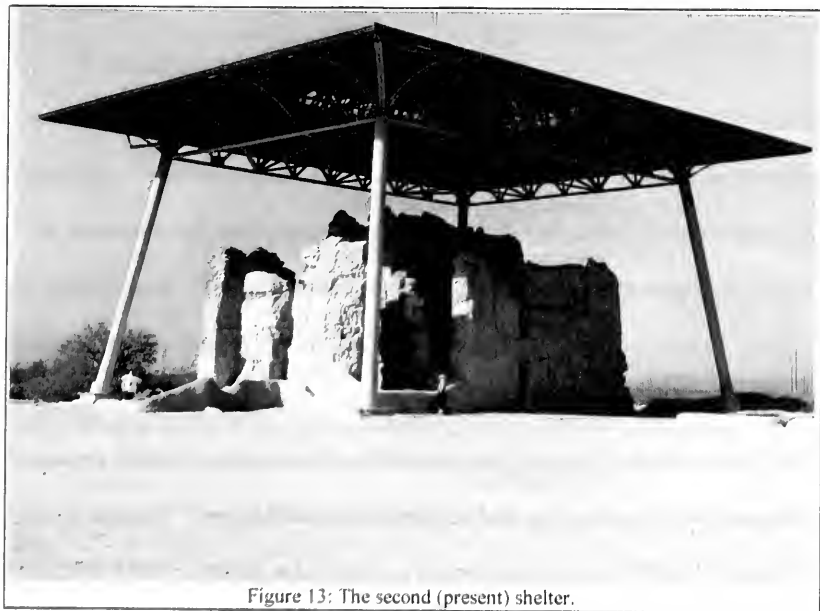
Figure 13: The second (present) shelter.

In 1932, funds to build the shelter were finally appropriated. The construction of the new roof was carried out by Allen Brothers of Los Angeles, California according to the design of Thomas Vint, chief landscape architect in the Park Service's San Francisco Field Headquarters. With only some exceptions, Vint followed the design suggested by Frederick Law Olmsted, Jr. The new shelter, formed by a hip roof on a steel frame that

stands forty-six feet from the ground to the eaves, was completed on December 12, 1932 (Clemensen 1992, 80).

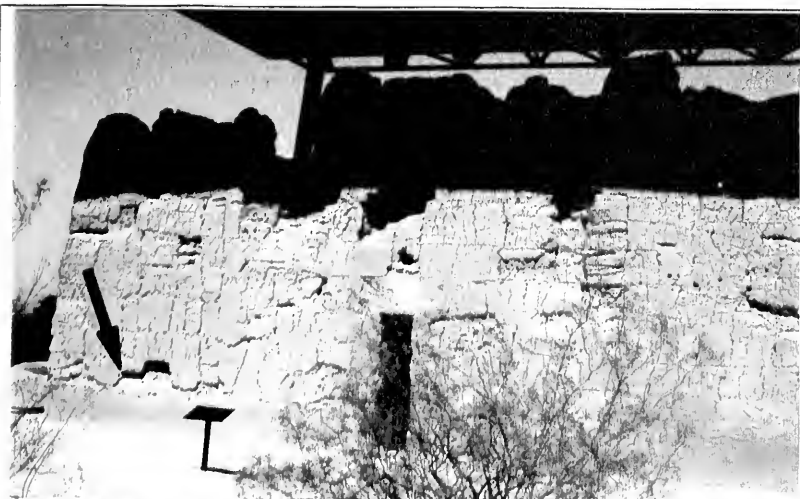
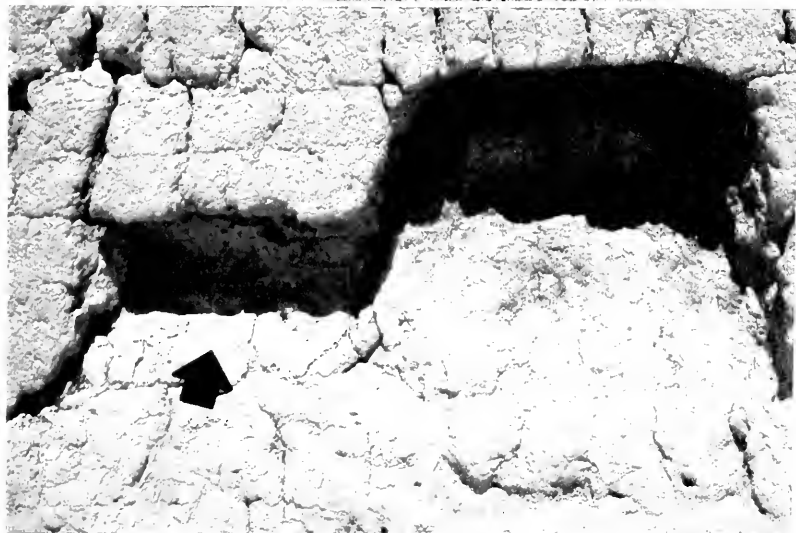
Figure 14: Location on the west elevation from where the fragment of caliche fell in 1995.
Figure 15: Close up of location.

The sample obtained for the present characterization was part of a large caliche fragment which fell from the outer side of the west wall of Tier A (west elevation), close to the northwest corner during the summer of 1995. The fragment, which fell entirely from the second course above the 1891-92 stabilization work (base wall fill), broke into three smaller fragments upon impact with the ground. The caliche material was still intact and cohesive considering the great weight of the fragment and the height from which it fell (approximately 1.30 m.). Observations and notes were taken concerning the orientation of the pieces in the wall.

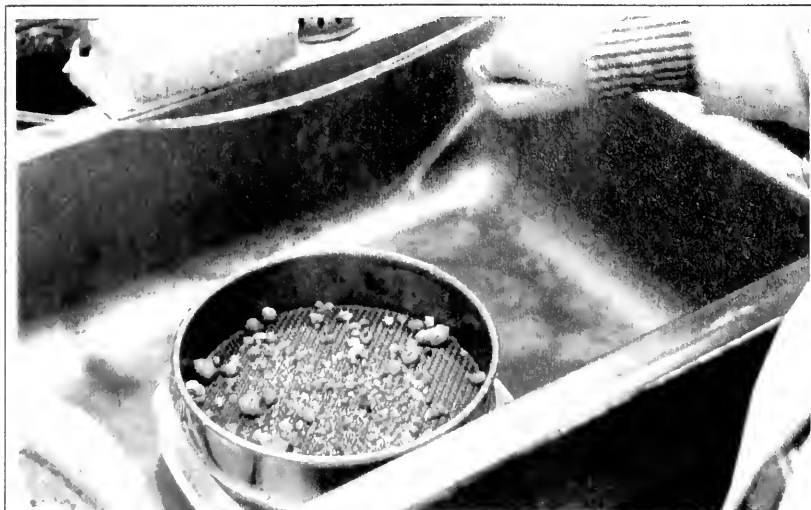
Figure 38: Separation of caliche by particle size using standard sieves and de-ionized water.

Each sample was sorted according to particle size with the use of standard sieves and de-ionized water (Figure 38) (see Appendix C for detailed procedure and results).

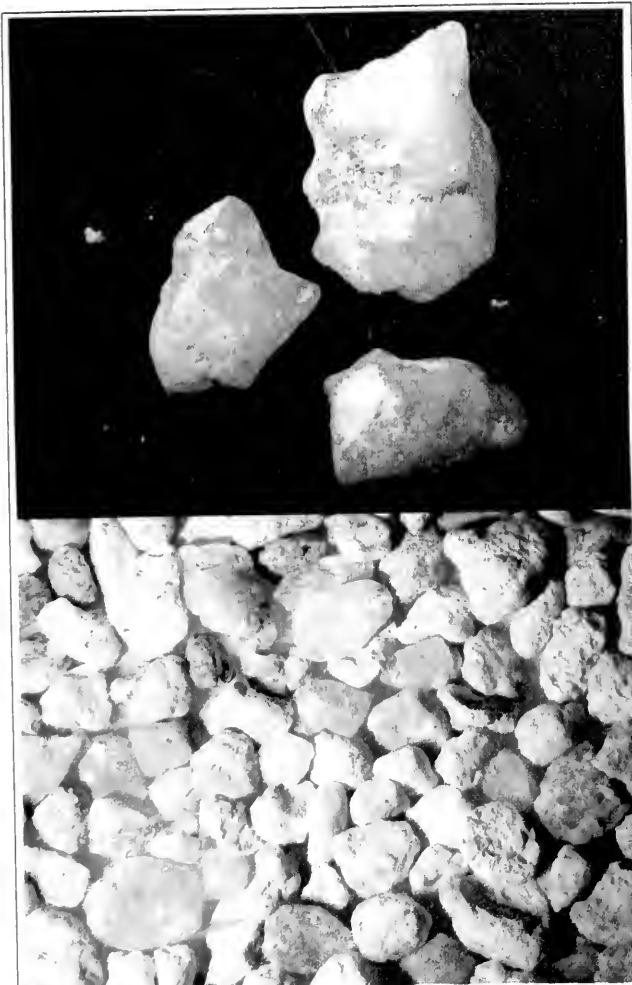
Figure 48 (top): Sand (quartz-like) particles partially coated by calcium carbonate matrix. Stereomicroscope. Mag.: 14X
 Figure 49 (bottom): Particles retained on sieve #30 (600µm). Approximately similar proportions of nodules and sand (quartz-like) particles compose this fraction of caliche. Stereomicroscope. Mag.: 14X

The non-nodule particles, mainly quartz or quartz like particles, are white, light gray and yellowish in color and tend to increase in

number as the particle size decreases. Like the nodules, these particles have various shapes, rounded to angular. In general, these particles tend to have sharp edges and corners, particularly the small ones.

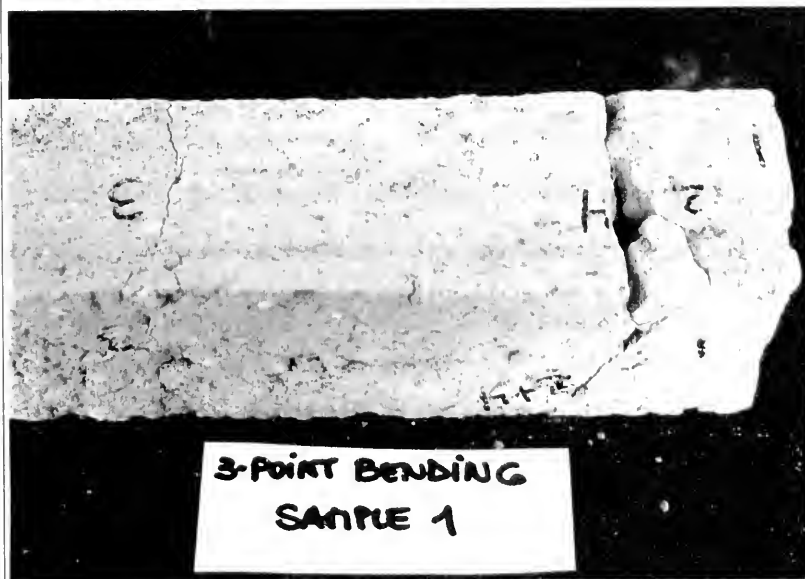
Figure 53 (top): Caliche specimen during the three-point bending test (modulus of rupture).
 Figure 54 (bottom): Caliche specimen after the three-point bending test (modulus of rupture).

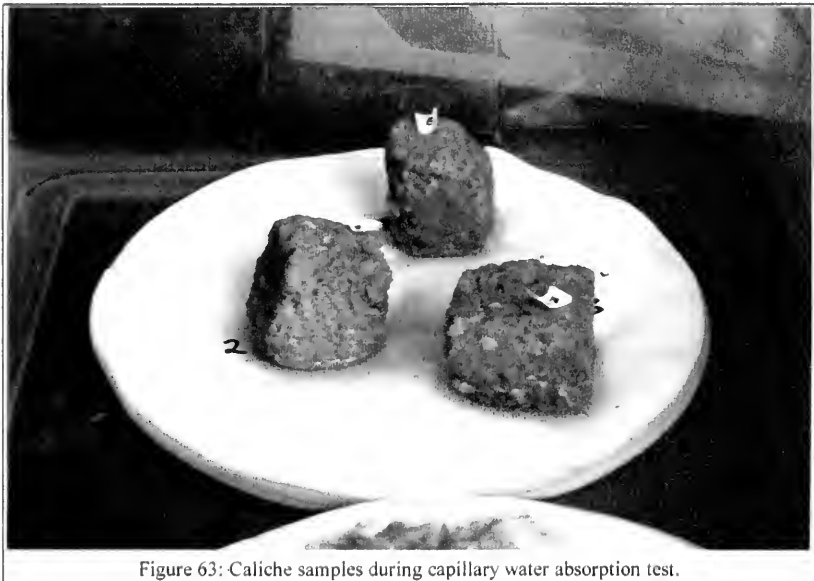
Figure 63: Caliche samples during capillary water absorption test.

The test procedure is described in Appendix C. Results are presented in table 9. Average values of capillary water absorption of each set of samples were calculated and plotted in a graph as a function of \sqrt{t} where time t (time) is given in minutes (figure 64).

This test again proved the extreme difference in behavior between samples CAGR Ext and CAGR Int. Samples CAGR Int displayed high water absorption with significant swelling that resulted in the disintegration of the samples after 4 hours (240 minutes) of testing.

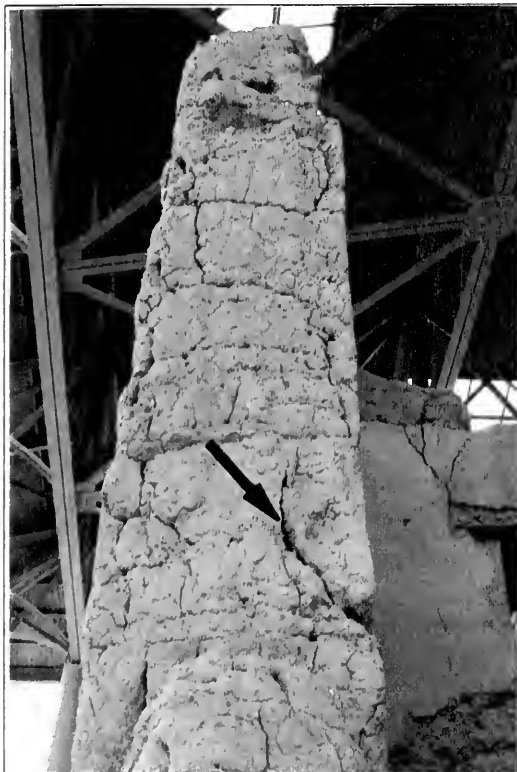
Figure 74: Crack on a wall end that suggests the proposed course construction

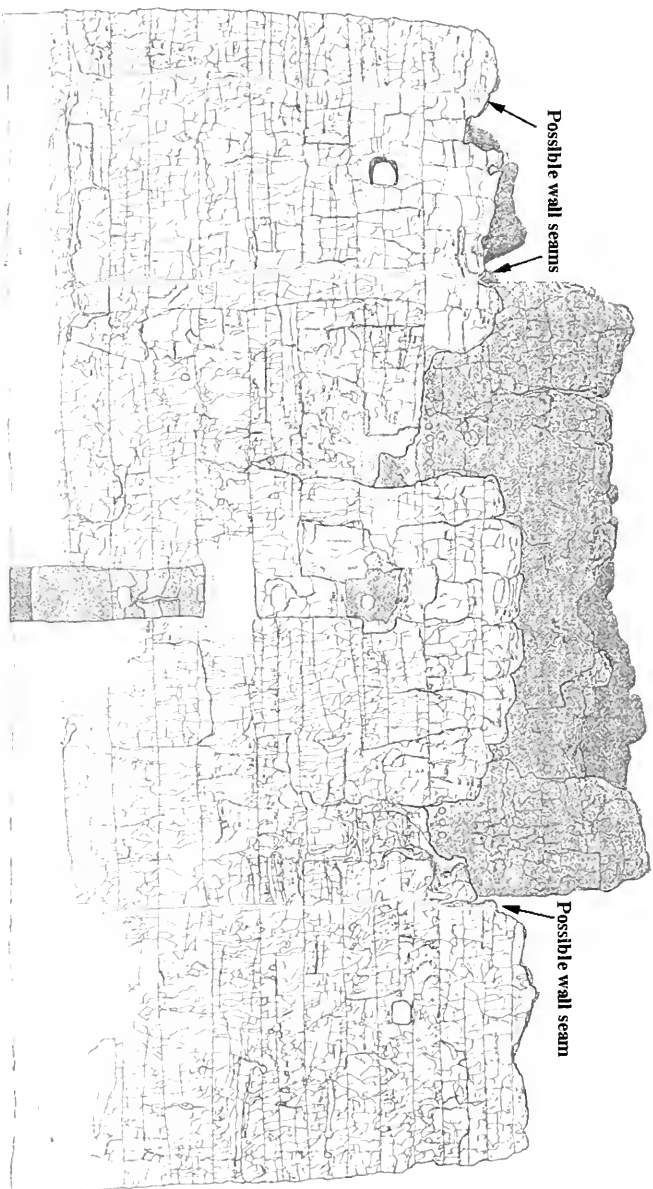
Figure 79: West elevation with evidence of tier construction (Myra, P and E. Borchers, Terrestrial photogrammetry of the Great House, 1979. Courtesy Casa Grande Ruins National Monument)

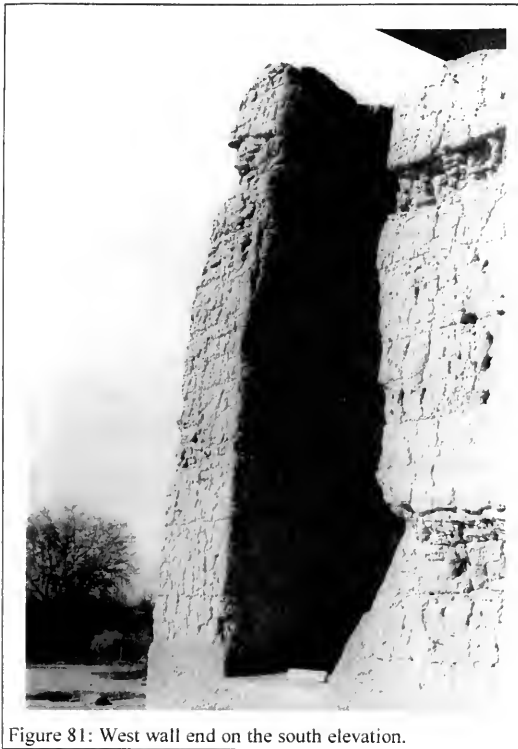
Figure 81: West wall end on the south elevation.

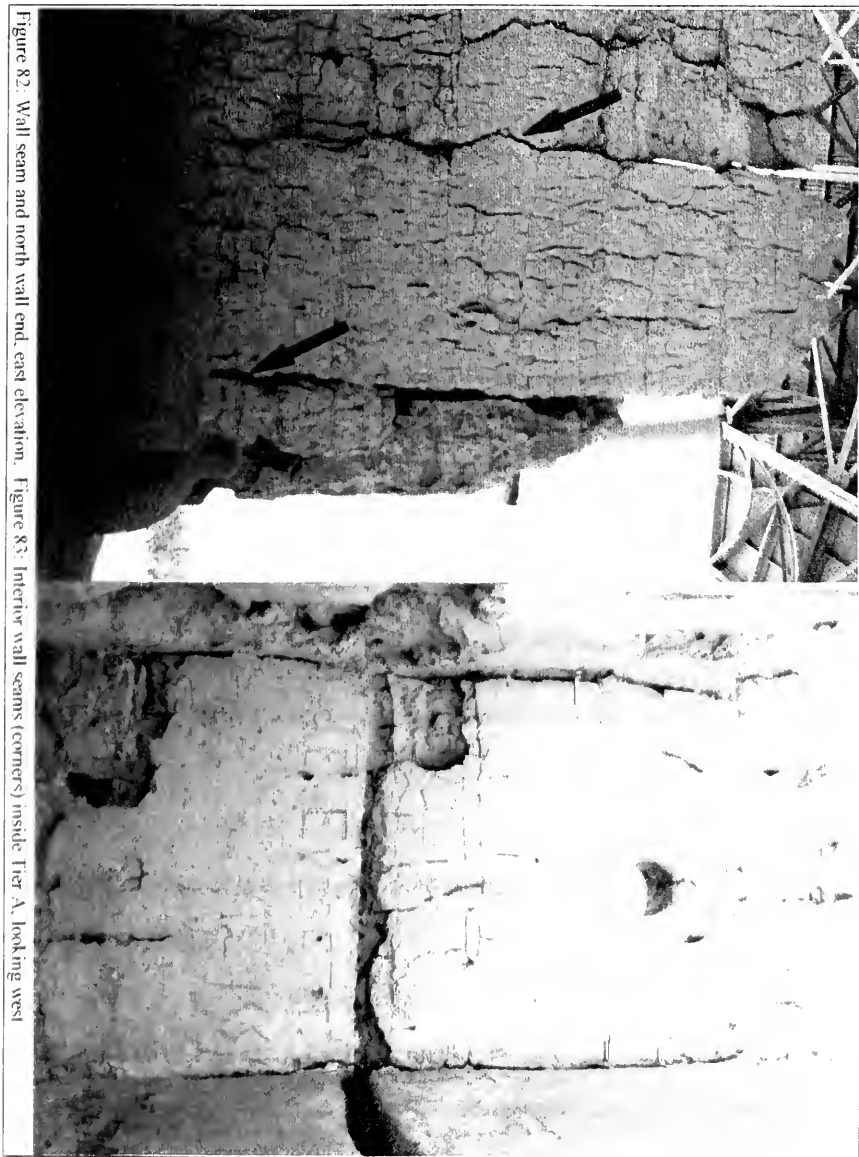
Figure 8.2. Wall seam and north wall end, east elevation. Figure 8.3. Interior wall seams (corners) inside Tier A, looking west

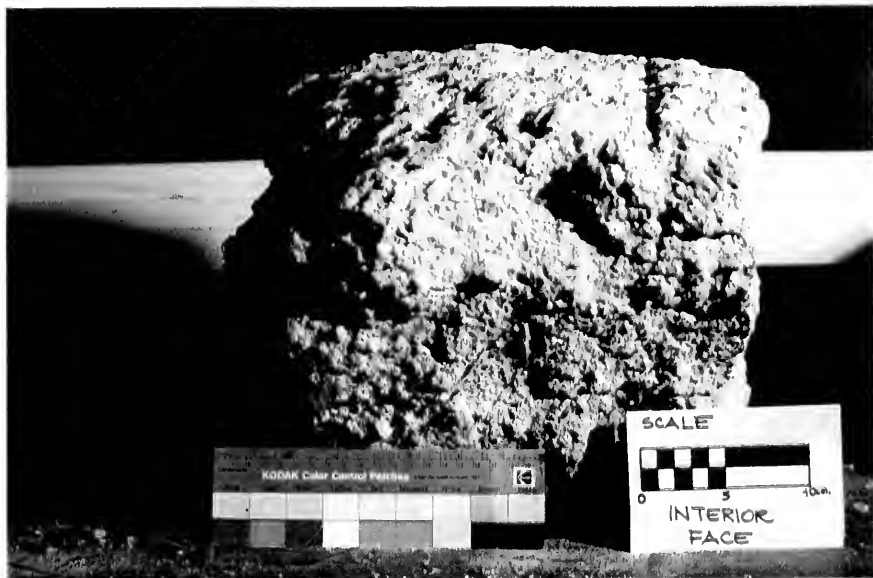
CALICHE FRAGMENT - LOWER FACE

Surface is not smooth and is very irregular. Several cracks. Surface is hard to the touch and even in color. Nodules and aggregates completely embedded in the soil matrix.

No insect activity on this face. This face has a depression in its central area.

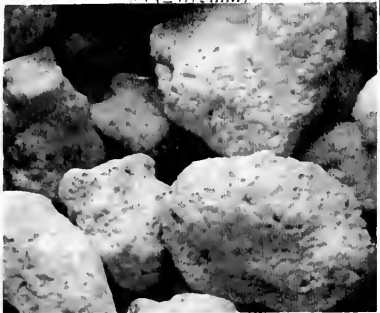
Particles retained #	Color (Munsell notation)	Observations
#4 ($\geq 4.75\text{mm}$)

5YR 8/2 pinkish white	Approximately 90% of these particles are composed of caliche nodules. Non-nodule particles are represented by quartz rich particles, mostly white, light gray and yellowish in color. Grain shapes are mostly rounded and subangular. Some of the non-nodule particles are glued together by a thin coating of calcium carbonate. High effervescence under a drop of 30% HCl.

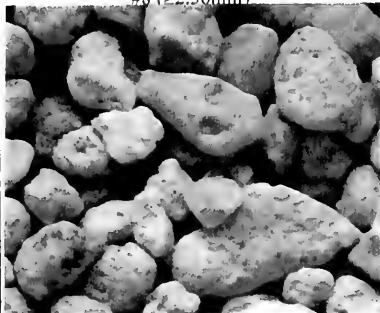
#8 ($\geq 2.36\text{mm}$)

5YR 8/2 pinkish white	Approximately 80% of these particles are composed of caliche nodules. Non-nodules particles are represented by quartz rich particles, mostly white, light gray and yellowish in color. Shapes are mostly rounded to subangular. Non-nodule particles are mostly subrounded to angular. Some nodules are formed by particles glued together and covered by calcium carbonate matrix. High effervescence under a drop of 30% HCl.

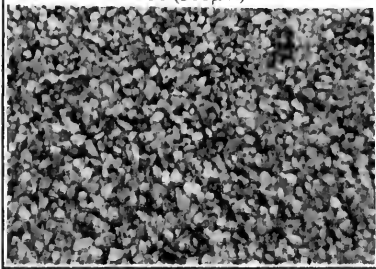
#50 ($300\mu\text{m}$)

5YR 7/3 pink	Approximately 40% of these particles are represented by caliche nodules, mainly subangular to angular. Non-nodules particles are mainly quartz rich particles, white, gray and yellowish in color, subrounded to angular. Medium effervescence under a drop of 30% HCl.
